EADIPS®
FGR®

**European Association for
Ductile Iron Pipe Systems**

NEWSLETTER

04/2019

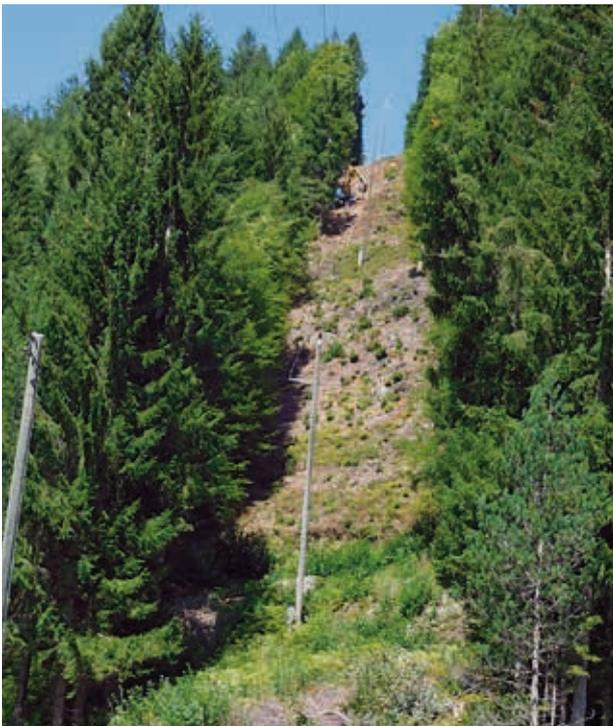
In order to protect ductile iron pipes against external factors, pipes with cement mortar coating were used. Delivering the usual pipe-bedding material on the steep slope was not possible.

The bedding of the pipes in conventional bedding material was not possible in this steep terrain, which is why **ductile iron pipes with cement mortar coating** were used. The coating provides reliable protection against e.g. rockfalls during installation which could damage the pipe. Thanks to the **VRS®-T restrained push-in joint**, there was no need for additional thrust bearings. The constant movements make it necessary to use **expansion compensation** (long-sleeve sockets), developed by [Tiroler Rohre GmbH](#).

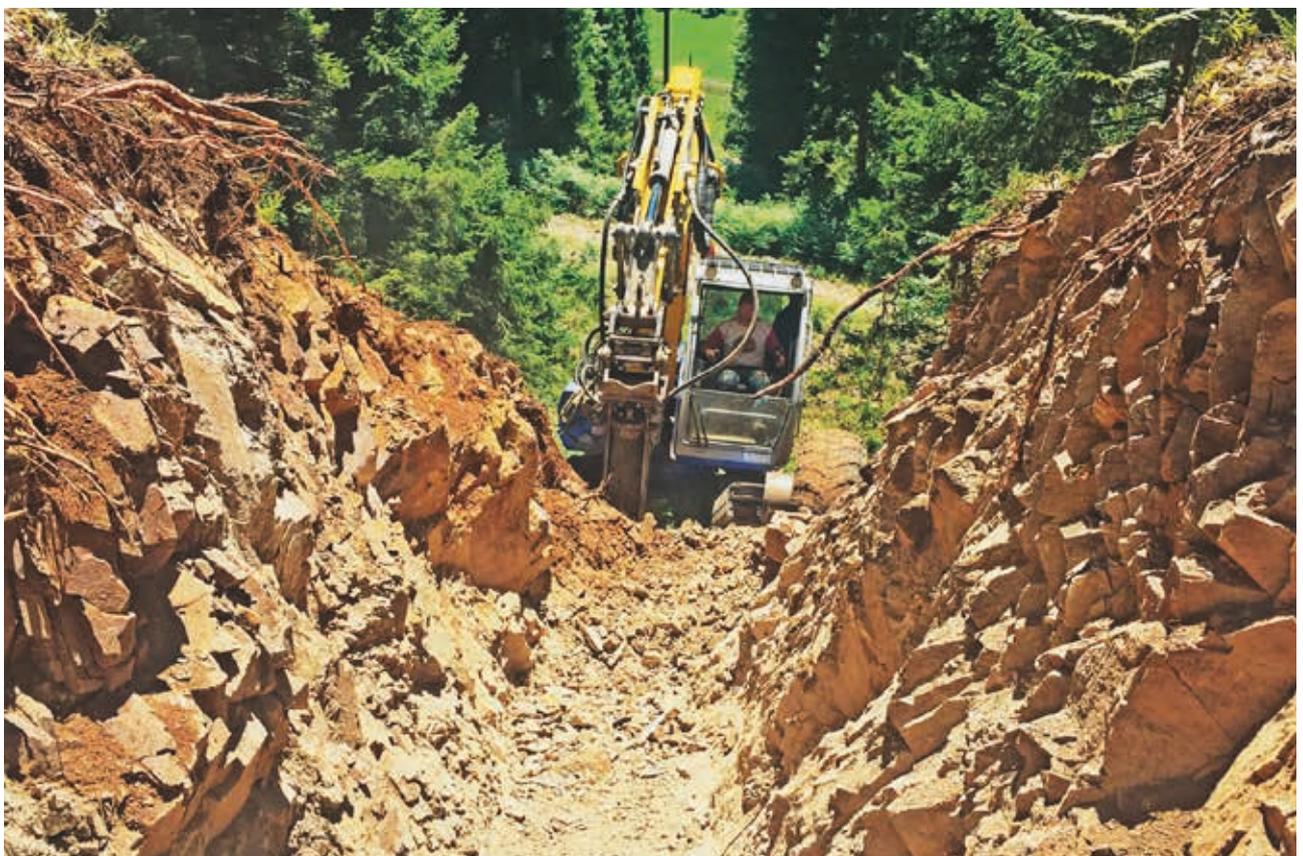
The spider not only dealt with the earth-moving work but it also transported the pipes.

The greatest challenge when constructing the wastewater pipeline was without doubt the earth-moving work and the transport of the pipes on the extremely steep gradient. The installation of the pipes was only possible with a so-called "spider", a walking excavator. With the help of independently controllable walking legs, it is also possible for the driver to carry out operations even in difficult terrain. But even with the equipment constructed for challenging earth-moving work, there were misgivings about its feasibility – a comparably steep construction site had not existed before.

The equipment operator from the Porr-Seiwald consortium took up the challenge with the "spider" and an additional winch securing device. So a trench was able to be excavated for the pipes in the conventional way, without the need for cost-intensive boring into the rock. The pipes were also transported with the walking excavator – a tough business.

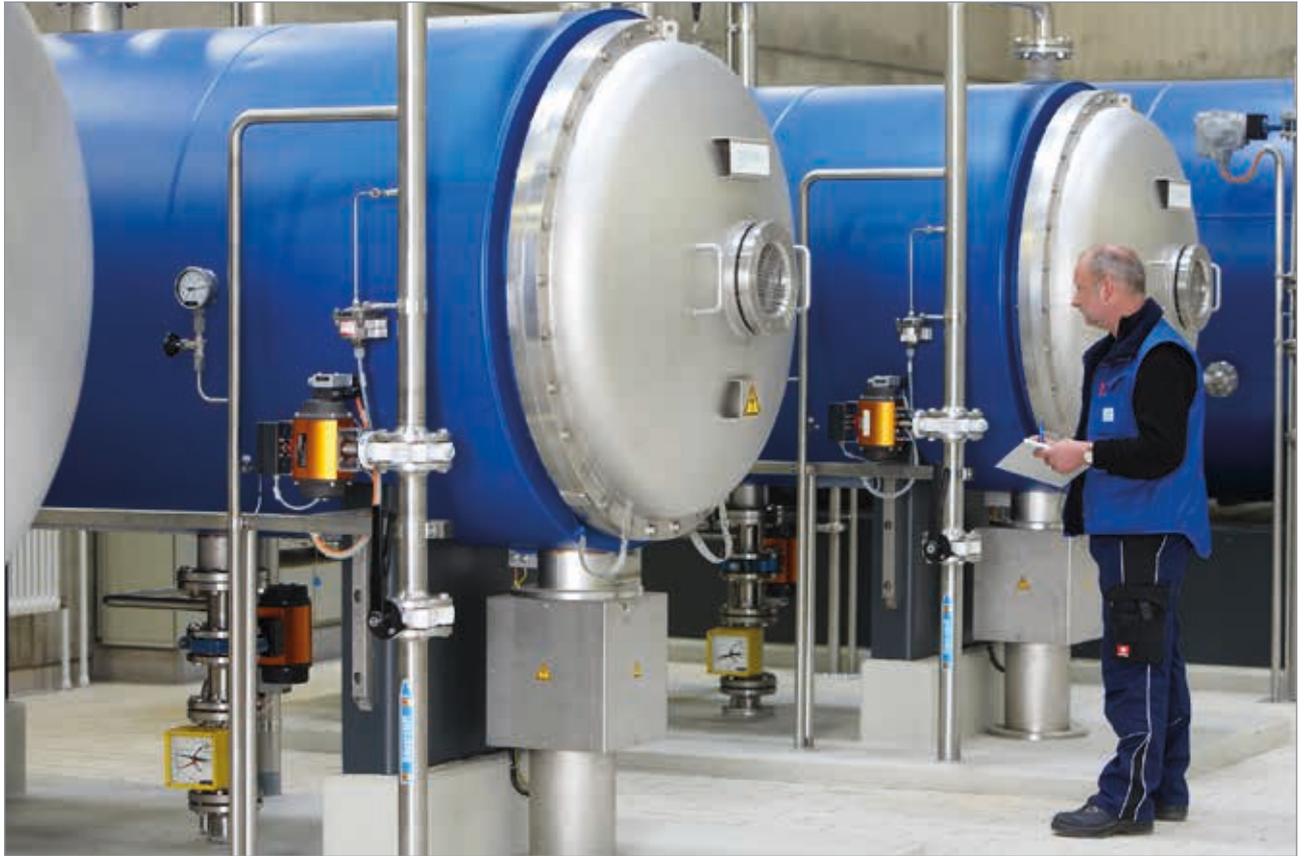
Conversion of oxygen into ozone in so-called tube ozone generators

The high-quality raw water of Lake Constance is disinfected during the treatment process by the addition of highly active oxygen (**ozone/O₃**). The ozone oxidizes dissolved and particulate organic substances, killing or inactivating any microorganisms still present. The ozone is produced from pure oxygen (O₂) immediately before it is added to the water. For this purpose, the oxygen is converted into ozone in so-called **tube ozone generators**. Injectors transport the ozone into the water, mixers distribute the tiny ozone bubbles evenly throughout the entire water body. The water then remains in large containers for at least 2 hours; during this time, disinfection takes place.

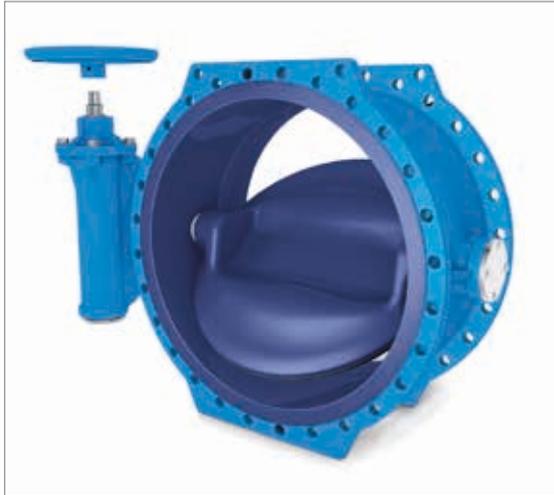
ERHARD butterfly valve ROCO Wave outside EKB, inside enamel coating

- high corrosion protection as the key to maximizing service life
- perfect hygienic conditions thanks to the smooth surface of the enamel components (Ra 0,05)
- residual substances in the water, as well as oxidized organic components of microorganisms, have difficulties to accumulate on the fitting, which contributes to the maintenance of water purity
- reduction of pressure loss due to extremely smooth surface, which increases efficiency and reduces energy consumption
- existing connection also under bending or other loads, such as internal pressure or pipeline forces
- Butterfly valves of nominal sizes DN 1200 and DN 1400 in pressure stage PN 10 and seals in EPDM (DVGW, KTW) were used for installation in the intermediate tank east/west of the ozone plant.

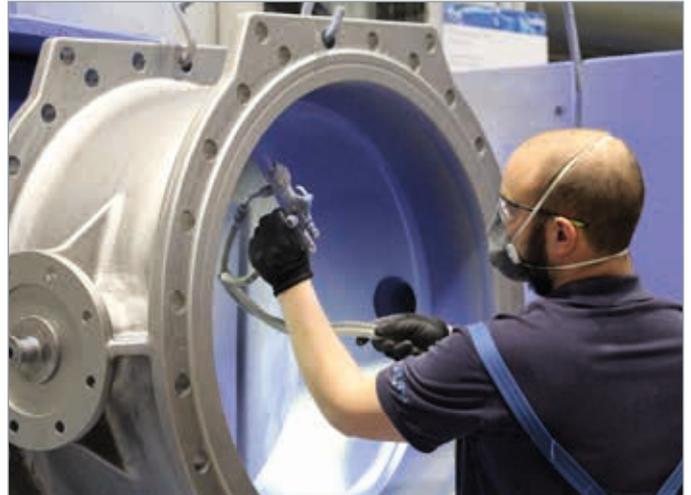
Application of the enamel coating by spraying
