EADIPS®
FGR®

**European Association for
Ductile Iron Pipe Systems**

NEWSLETTER

03-04/2017

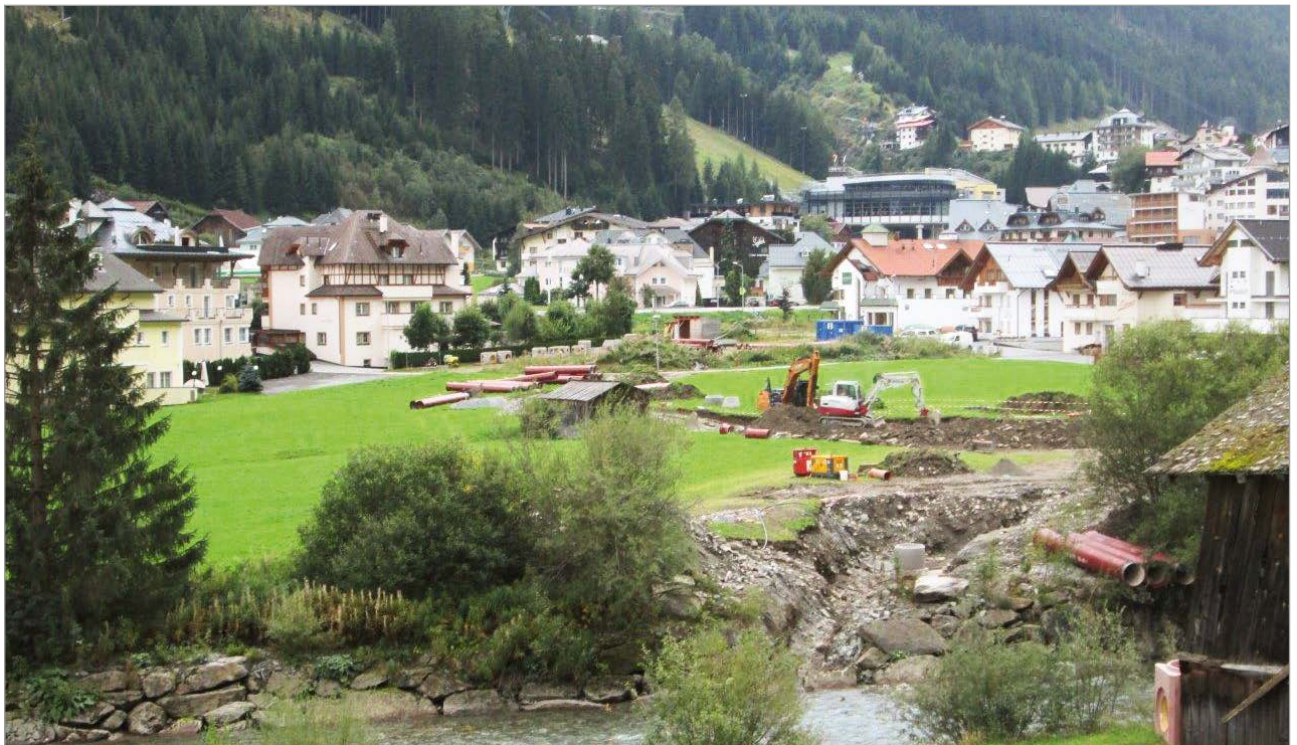
The route taken by the pipeline on the outskirts of Ischgl

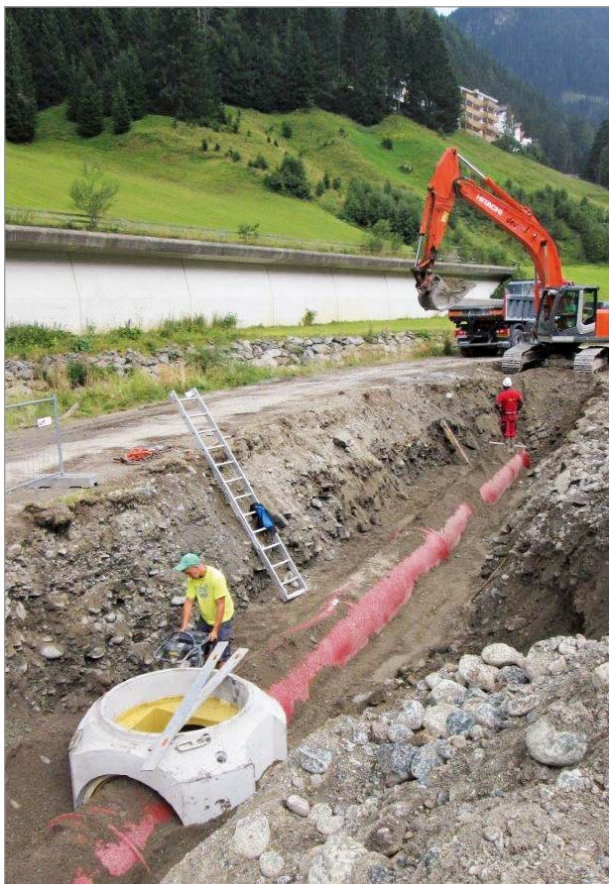
Backfilling the trench after installation of the manholes and the pipes with protection against extraneous water.

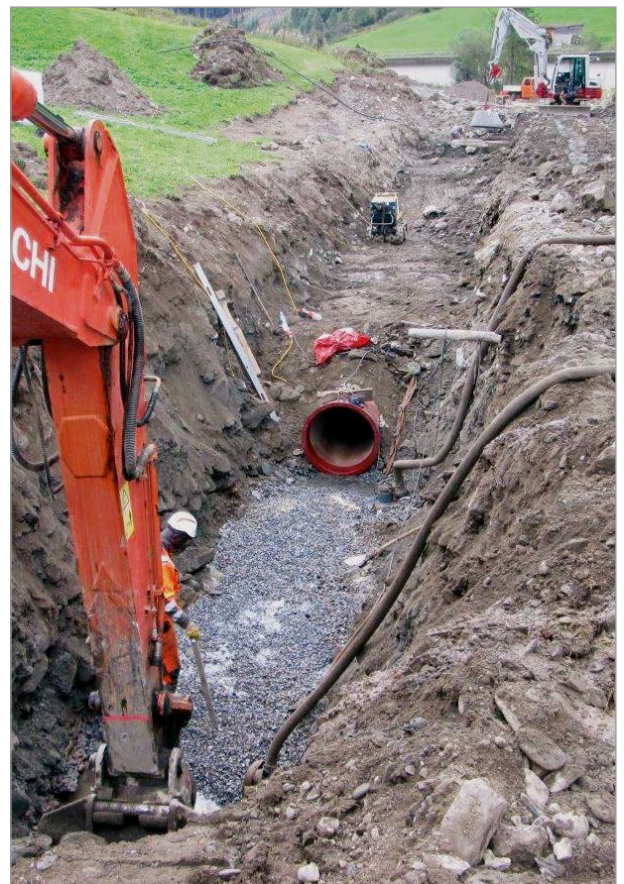
Installation of the ductile iron pipes in an area exposed to groundwater.

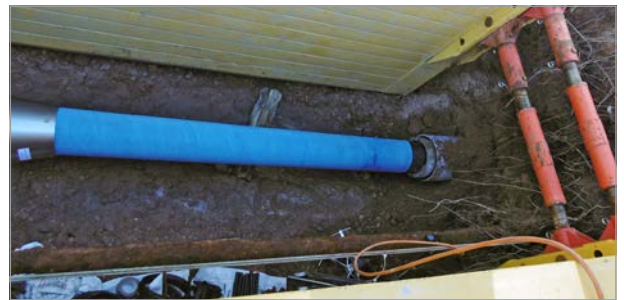
Bursting head with a DN 200 ductile iron pipe attached during the pulling-in process.

The pipeline lies in a landscape conservation area. Because of this, a large part of the pipeline was installed using the trenchless burst lining technique. In addition, this also meant a cost saving of around 50% as compared with the open trench method. With trenchless pipe installation, the external protection of ductile iron pipes is exposed to a variety of mechanical stresses from the outside. In order to avoid damage here, the use of coatings with a high resistance to mechanical stresses is recommended. This is particularly applicable to pipes which are installed with the burst lining technique as the burst fragments of the old pipe remain in the soil and can come into contact with the new pipe during the pulling-in process. The cement mortar coating used here provides the pipes with the ideal protection against mechanical damage.

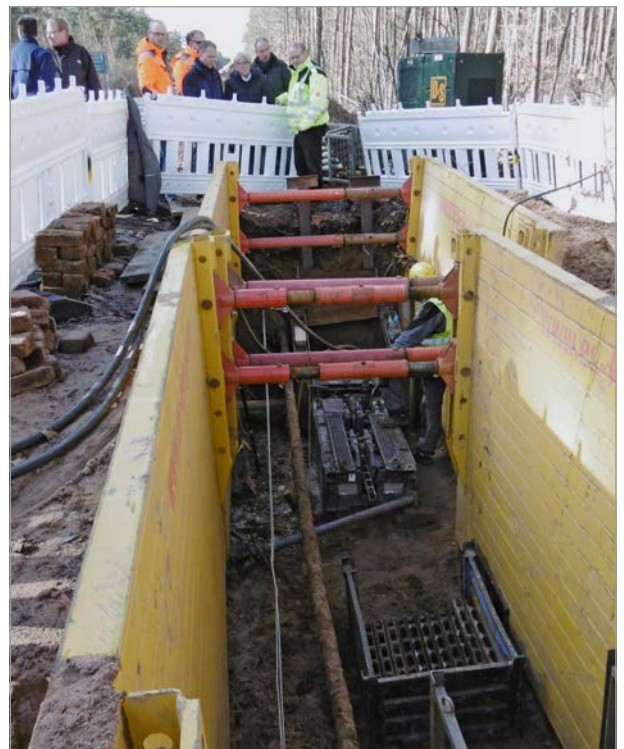
Machine with traction rods in a target pit.

Altogether, a section of approx. 2,000 m was replaced, of which 1,900 m was done with the burst lining technique. The longest pipe run replaced in one go consisted of 28 pipes and was 168 m long. The machine used for this, from Diringer & Scheidel Bauunternehmung GmbH & Co. KG, had a maximum pulling force of 80 t.

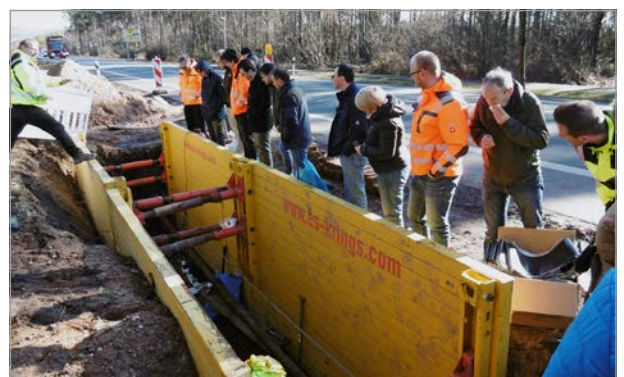
The installation of restrained ductile iron pipes and the burst lining technique is explained pit-side to an interested public.

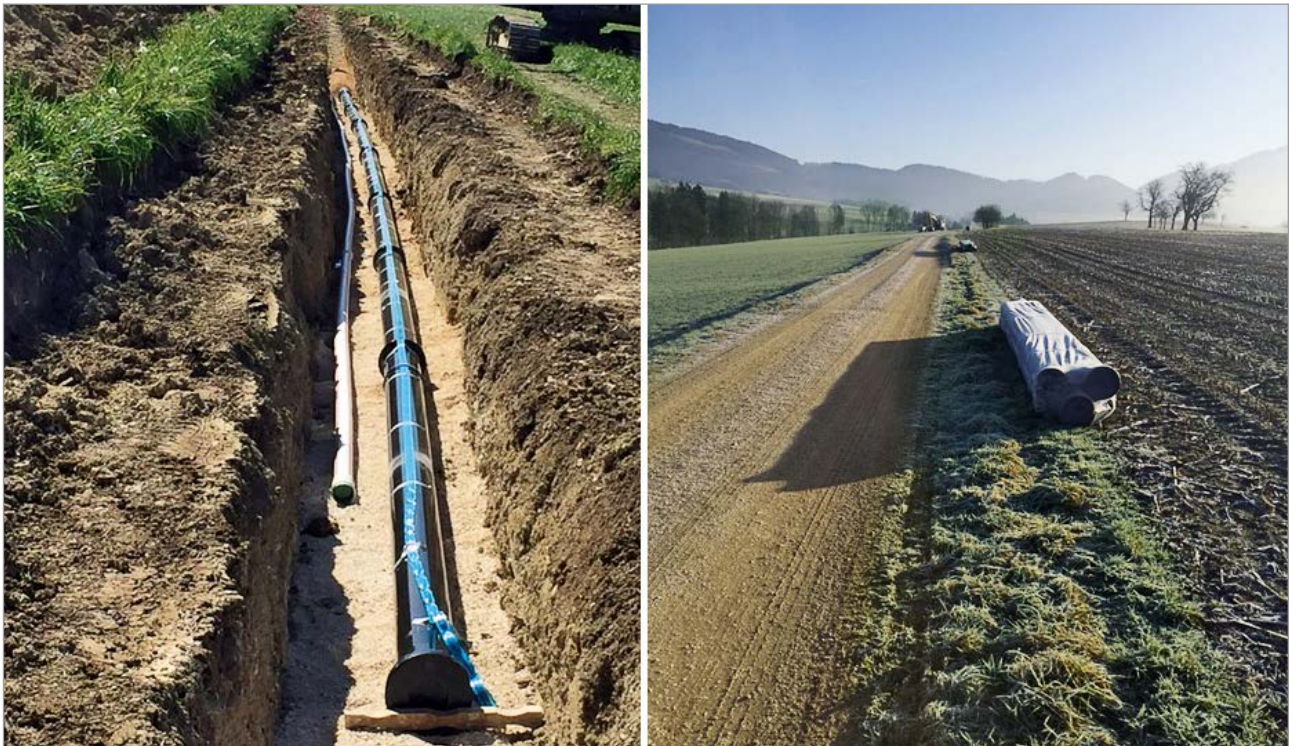
Transport pipeline between the villages of Mervelier and Vicques during installation work

Because of the superior economically, ecologically and technically sustainable characteristics of ductile iron pipe systems, the client – SEVT – decided in favour of Swiss vonRoll ECOPUR full-protection pipes in ductile cast iron for the renewal of its drinking water supply. The ECOPUR pipes, produced in accordance with EN 545, are integrally coated, inside and out, with polyurethane (PUR). The vonRoll ECOFIT fittings used have an epoxy coating to GSK/RAL-GZ 662. All the push-in joints in the piping system were secured with the restrained vonRoll HYDROTIGHT thrust resistance system.
